Wang, P., Tidwell, D. K., Beck, T. M., and Kraus, N. C. 2007. Sedimentation Patterns in a Stabilized Migratory Inlet, Blind Pass, FL. *Proceedings Coastal Sediments '07 Conference*, ASCE Press, Reston, VA, 1377-1390.

SEDIMENTATION PATTERNS IN A STABILIZED MIGRATORY INLET, BLIND PASS, FLORIDA

Ping Wang¹, David K. Tidwell¹, Tanya M. Beck¹, Nicholas C. Kraus²

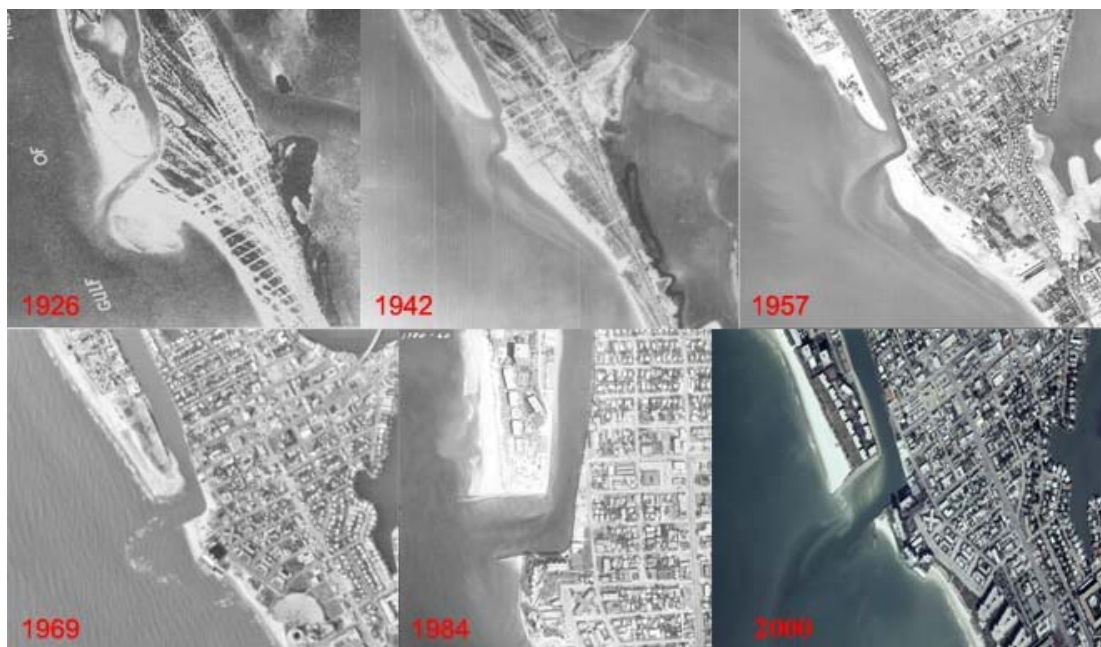
Fig. 2. Time-series aerial photos of Blind Pass.

Artificial interferences on the morphodynamics of Blind Pass are illustrated well by time-series aerial photographs (Fig. 2). Blind Pass is characterized by a nearly 90-deg. turn before entering the Gulf of Mexico. We focus on the entrance channel at and gulfward of the turn. In 1926 (Fig. 2A), the inlet was still in pristine condition. A large ebb shoal and southward sand bypassing are apparent. By 1942 (Fig. 2B), the south side had been stabilized. The ebb delta and southward bypassing are still visible, but to a reduced degree. Beach erosion at Treasure Island to the north becomes obvious. By 1957 (Fig. 2C), the ebb shoal and southward bypassing are still visible. At the same time, erosion at the updrift Treasure Island had become severe. By 1969 (Fig. 2D), both sides of the inlet were stabilized. The ebb shoal and southward bypassing diminished substantially. Through a combination of jetty, groin field, and beach nourishment, erosion at the updrift Treasure Island was mitigated. However, severe erosion at downdrift Upham Beach to the south developed. Shoaling of the inlet channel and severe erosion downdrift are the main features of the 1984 photo (Fig. 2E), which was taken a year after the 1983 dredging. The ebb shoal and southward bypassing become indistinguishable. This trend continued and is shown in the 2000 photograph (Fig. 2F) just before the last dredging to date. The present study on shoaling in the channel was commenced after the 2000 dredging.

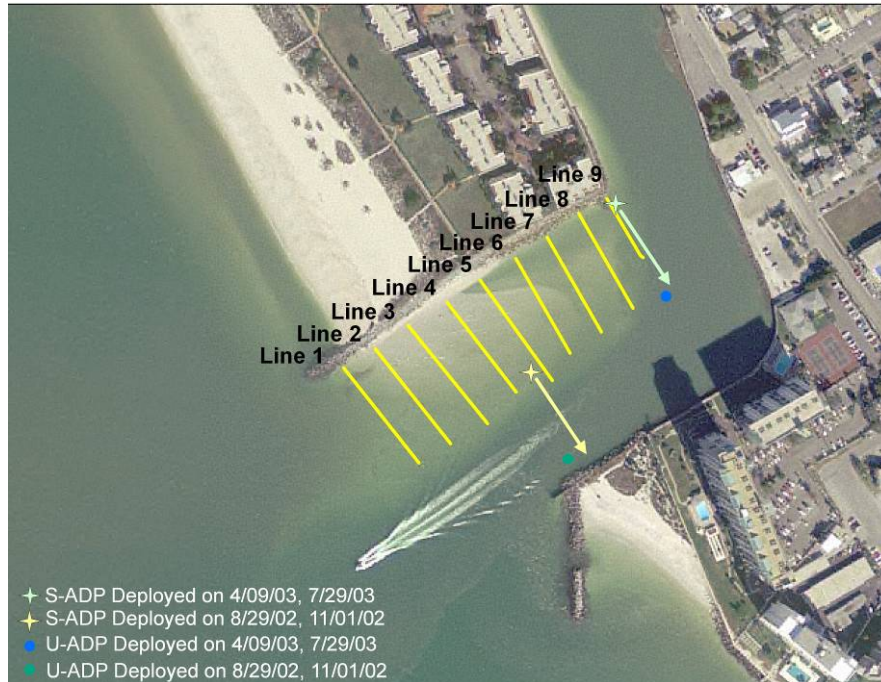
Fig. 3. The north shoal profiles and locations and times of current meter deployments.

The present study examines sediment shoaling in the Blind Pass entrance channel via a series of field investigations, through which a numerical model of circulation was established. Time-series bathymetric surveys were conducted, as well as flow measurements. Bathymetric surveys were conducted roughly quarterly from August 2002 to June 2004. The surveys were conducted with a combination of precision echo sounder for depth and a synchronized Real-Time-Kinematic (RTK) Global Positioning System (GPS) for position. Water level variations were measured to cross-check the tidal influence on the floating platform survey. During the study, the northern side of the inlet became too shallow to survey by boat. Level-and-transit surveys using an electronic total station were conducted there monthly from February 2003 to February 2004. The monthly survey of 9 lines over the northern shoal, extending to roughly 1.5 m water depth, was designed to capture the infilling rate and pattern over this active shoaling area (Fig. 3). Surveys are referenced to NGVD29, which is roughly 0.15 m below mean sea level in this area.

Tidal flow patterns through the inlet were measured using an upward-looking acoustic Doppler current profiler (U-ADP) in combination with a side-looking ADP (S-ADP). Therefore, flow patterns both through the water column and across the channel were measured. The flow measurements were conducted at two locations with one near the mouth and one near the bend, each for approximately one month (Fig. 3). In addition, flow velocities were measured simultaneously using two U-ADP placed in the thalwegs near the entrances of Johns Pass and Blind Pass. These data are valuable for examining the interaction of the two inlets and for validating the circulation model.

Sedimentation on the north shoal was monitored through monthly surveys of nine lines (Fig. 3). Four areas with different patterns of accumulation and erosion in the shoal can be distinguished as the: mouth area (lines 1 and 2), middle area 1 (lines 3 and 4), middle area 2 (lines 5 and 6), and the inner area (lines 7 through 9). From February to August, or the summer of 2003, a considerable amount of scour occurred in the mouth area (Fig. 11A). Little change was observed during the next two months. A tremendous amount of shoaling occurred in the mouth area between October and December of 2003, or at the beginning of the winter season. Scour was measured during the late winter between December 2003 and February 2004. Further into the inlet in middle area 1, little change occurred during the summer (Fig. 11B). A large amount of shoaling occurred at the beginning of winter, followed by further accumulation during late winter. Even further into the inlet at middle area 2, little change was observed during most of 2003 (Fig. 11C). A tremendous amount of shoaling occurred in the late winter. Near the bend of the inlet at line 9, southward progradation of the shoal occurred throughout the year (Fig. 11D). A large amount of shoaling was also observed during late winter.

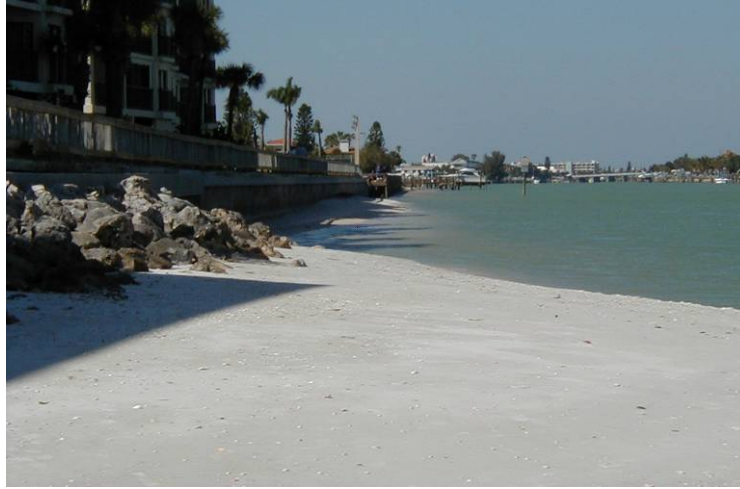
Fig. 10. Beach development along the back side of Treasure Island at Blind Pass, looking north.

From August 2002 to August 2003, net sedimentation of 17,000 m³ occurred, as the sum of 25,000 and 2,800 m³ accumulation from August 2002 to December 2002 and from August 2002 to May 2003, respectively, and 11,000 m³ of erosion from May 2003 to August 2003. From August 2003 to June 2004, net accumulation of 26,000 m³ occurred. For both years, net accumulation occurred in the winter months and net erosion in the summer months. This seasonal trend is reflected more clearly in the monthly north-shoal survey, discussed in the following. The reduced amount of sedimentation during 2003 and 2004 is related to sediment backpassing around the corner of the inlet. A beach has developed on the back side of Treasure Island since 2003 and is growing (Fig. 10).
